**SBS Building**  
fka National Old Line Insurance Building

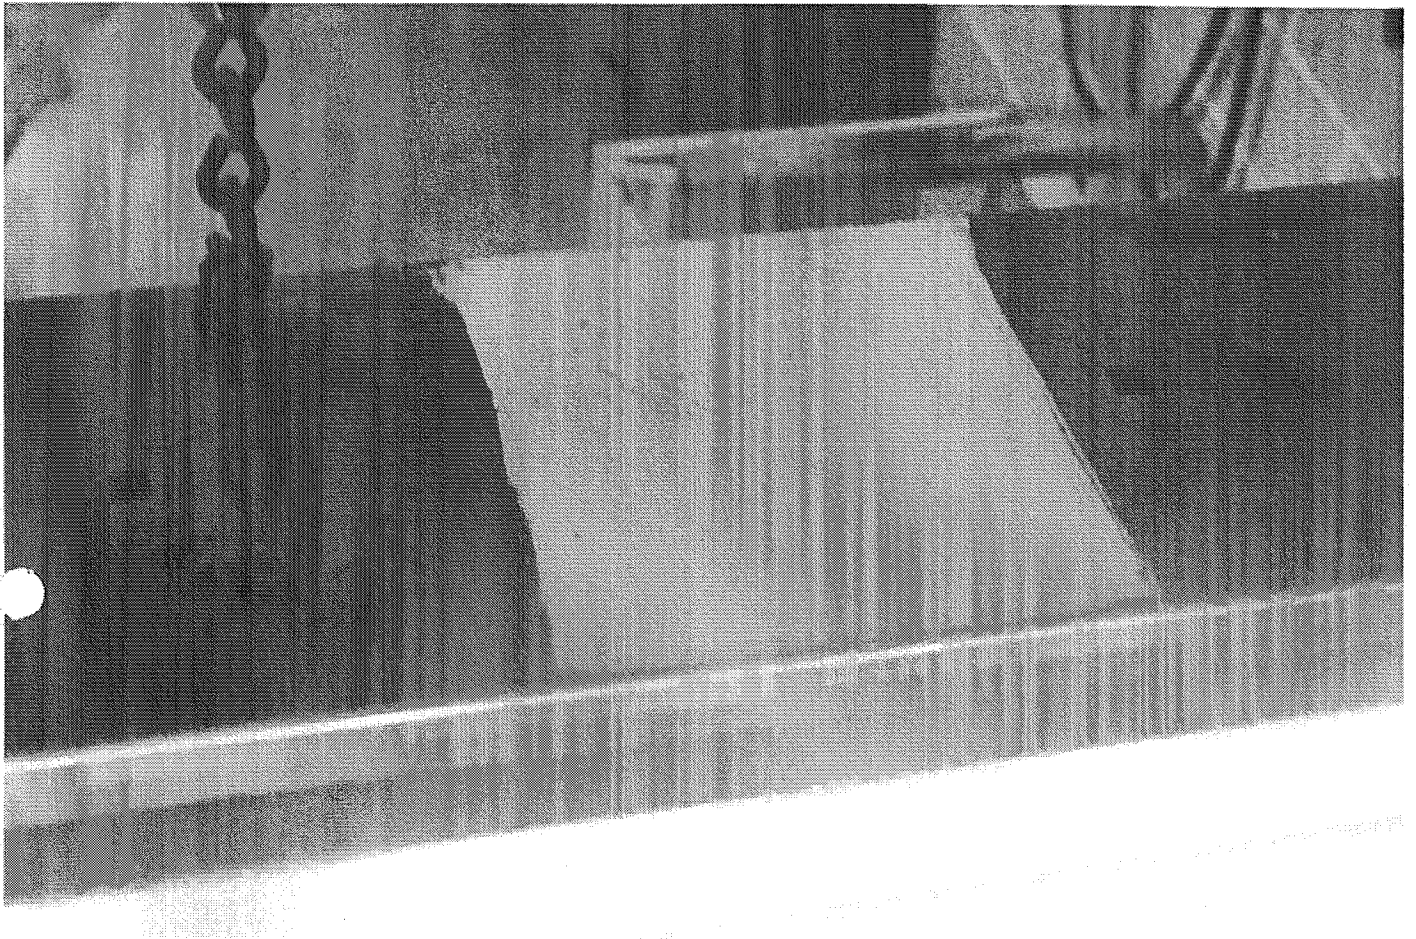
31. electrical office - top of fluorescent light fixture after sampling - location of sample #5

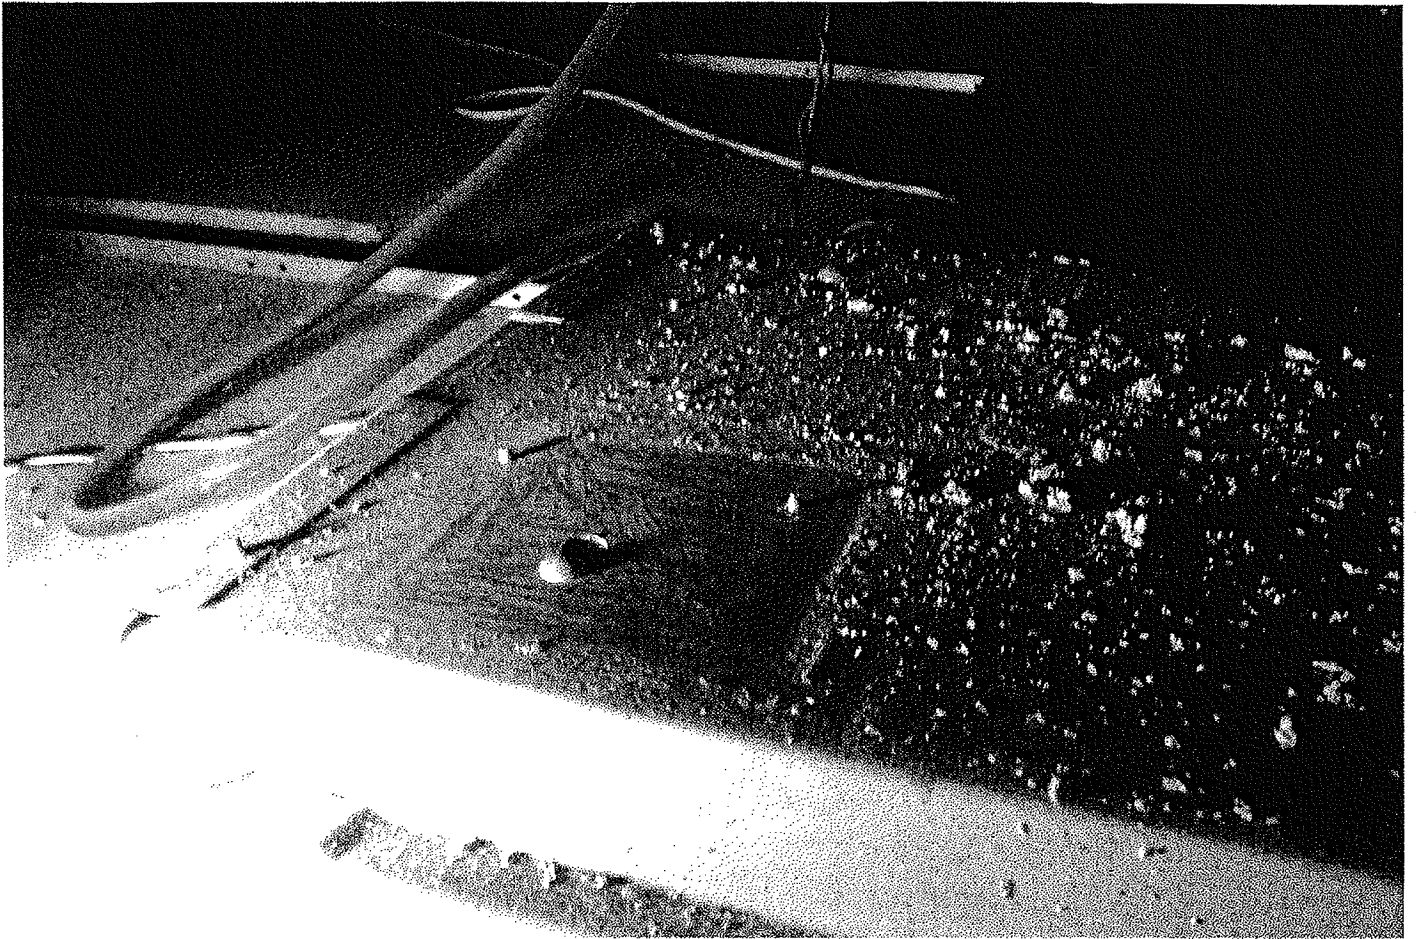
32. G Floor Meeting Rm - Location of sample #1 - top of filuorescent light fixture

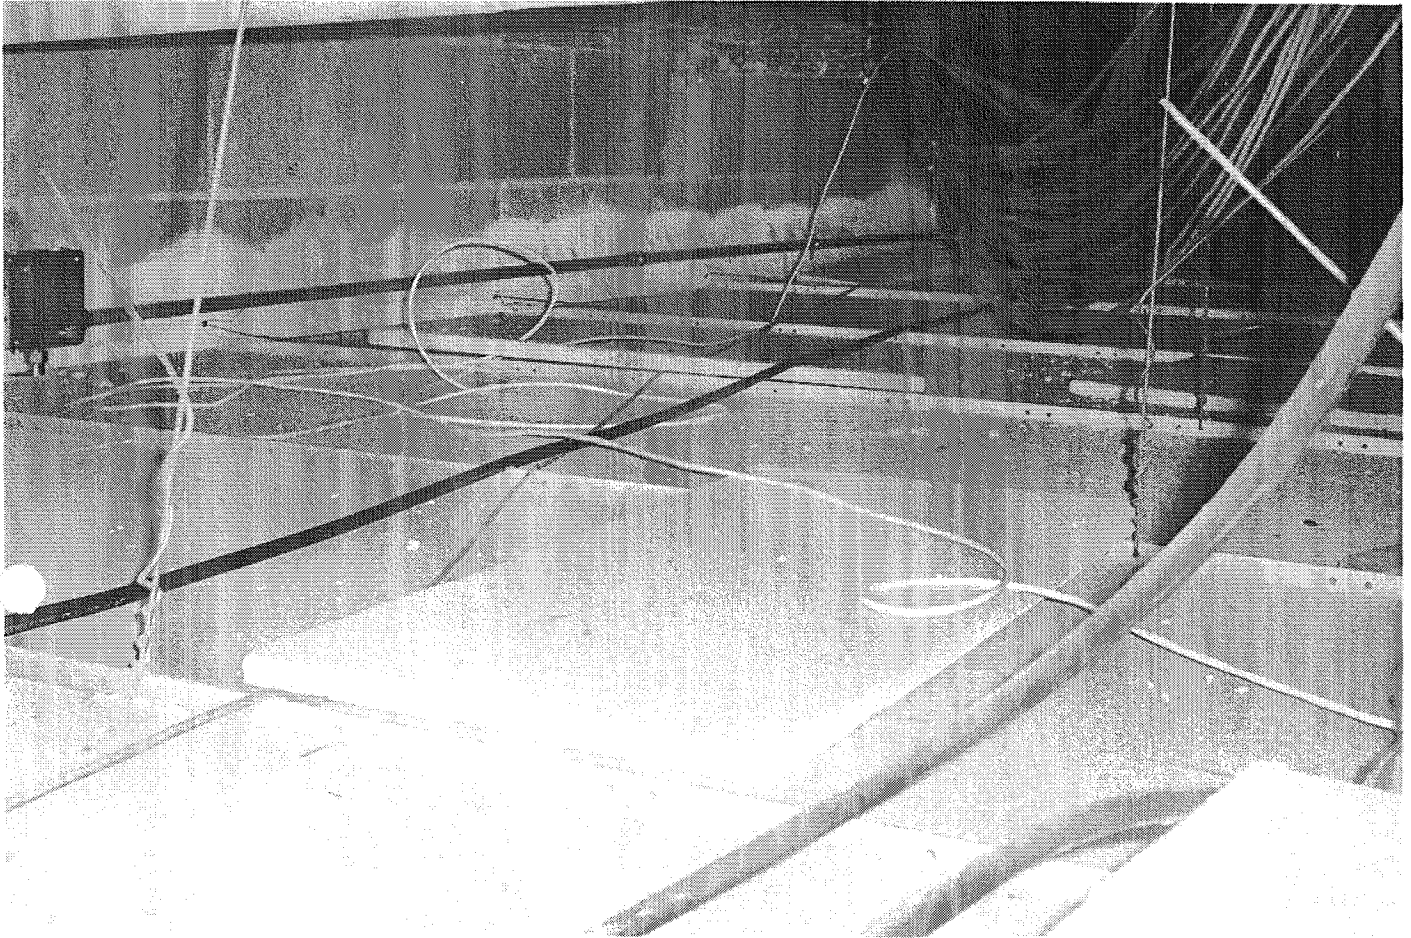
33. G Floor Meeting Rm - View of delaminated fireproofing above suspended ceiling

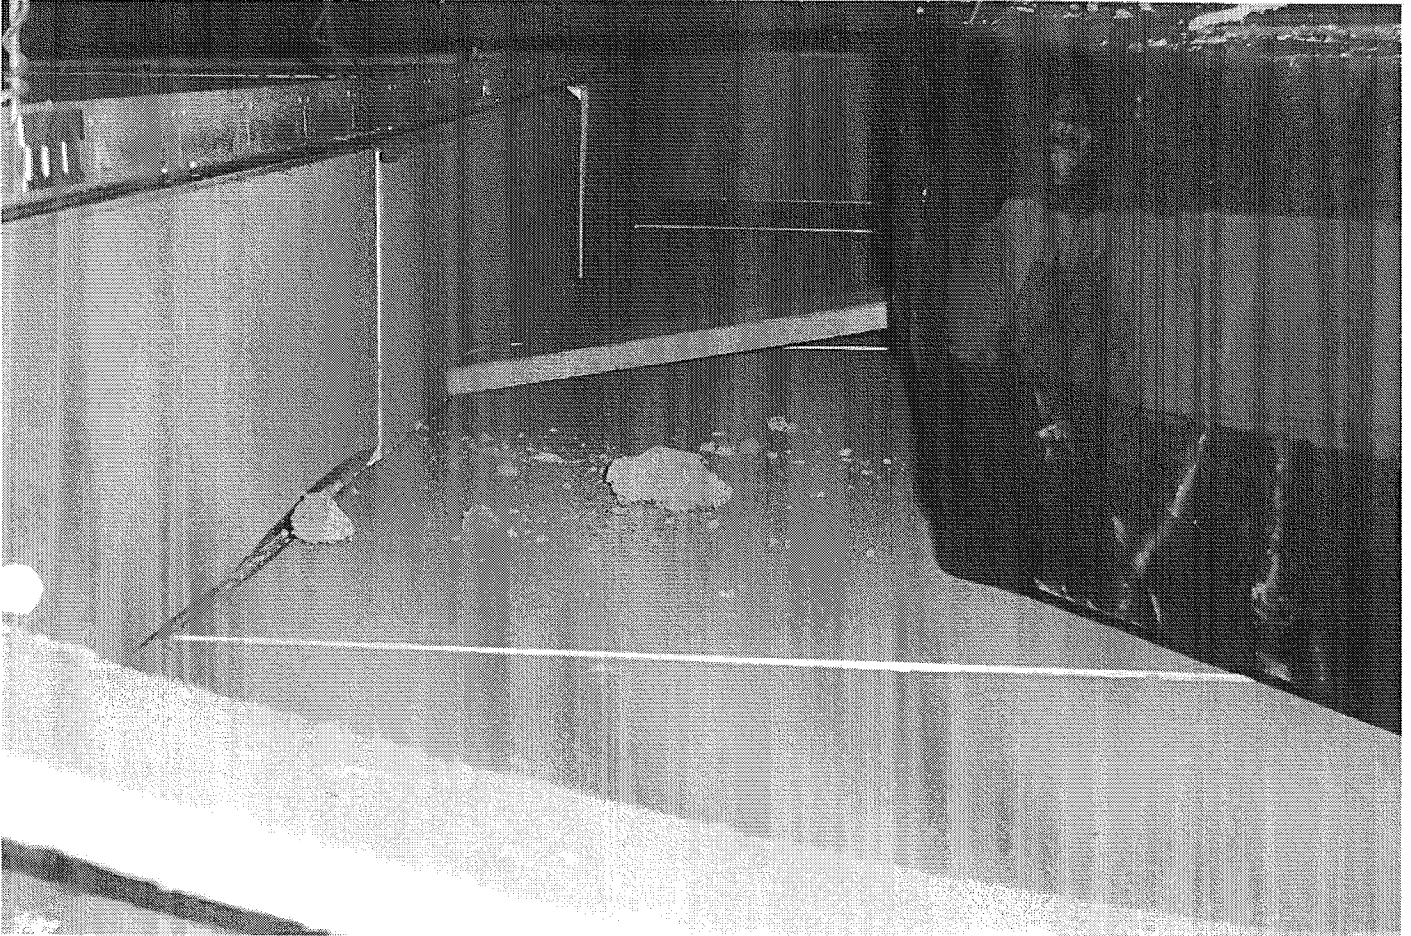
34. B Floor West Mech Rm - View of large chunks of delaminated fireproofing debris on top of suspended ceiling
